Restoration of Goose Creek and Big Meadows
Conceptual Design Plan

Kalispel Tribe of Indians

April, 2010

CONFLUENCE

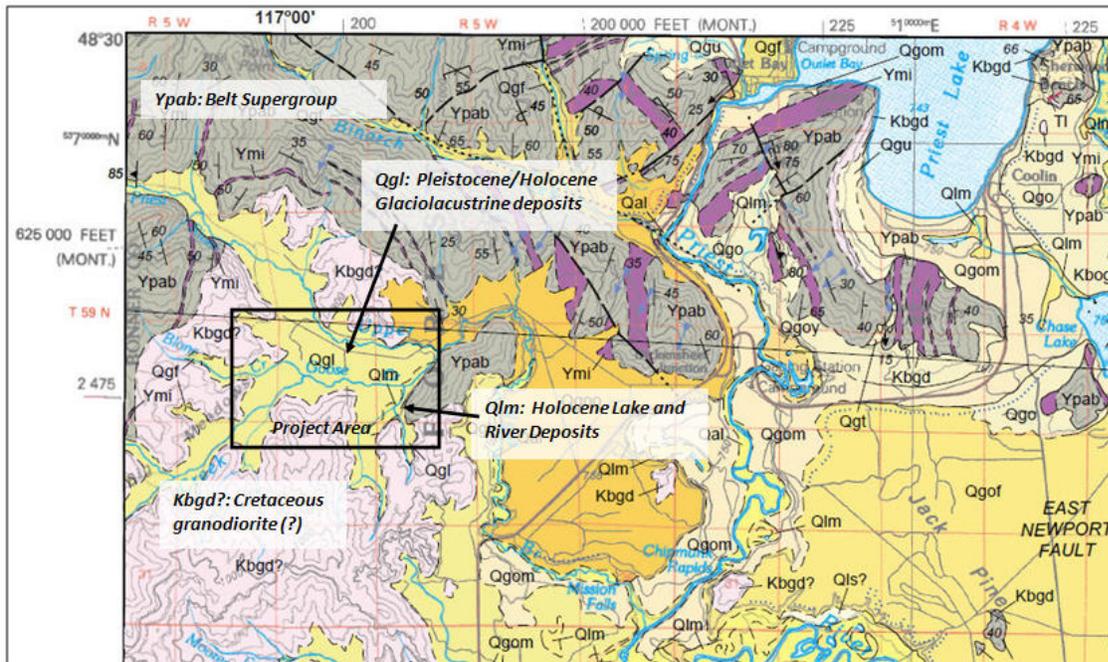
Figure 2. Geologic map of project area (Lewis and others, 2008).

The geologic mapping in the project reach (Figure 2) coupled with pit stratigraphy collected in support of channel design indicate that glacio-lacustrine conditions did exist in the project area resulting in the deposition of fine grained glacial lake deposits, and overlying peats are associated with subsequent deglaciation.

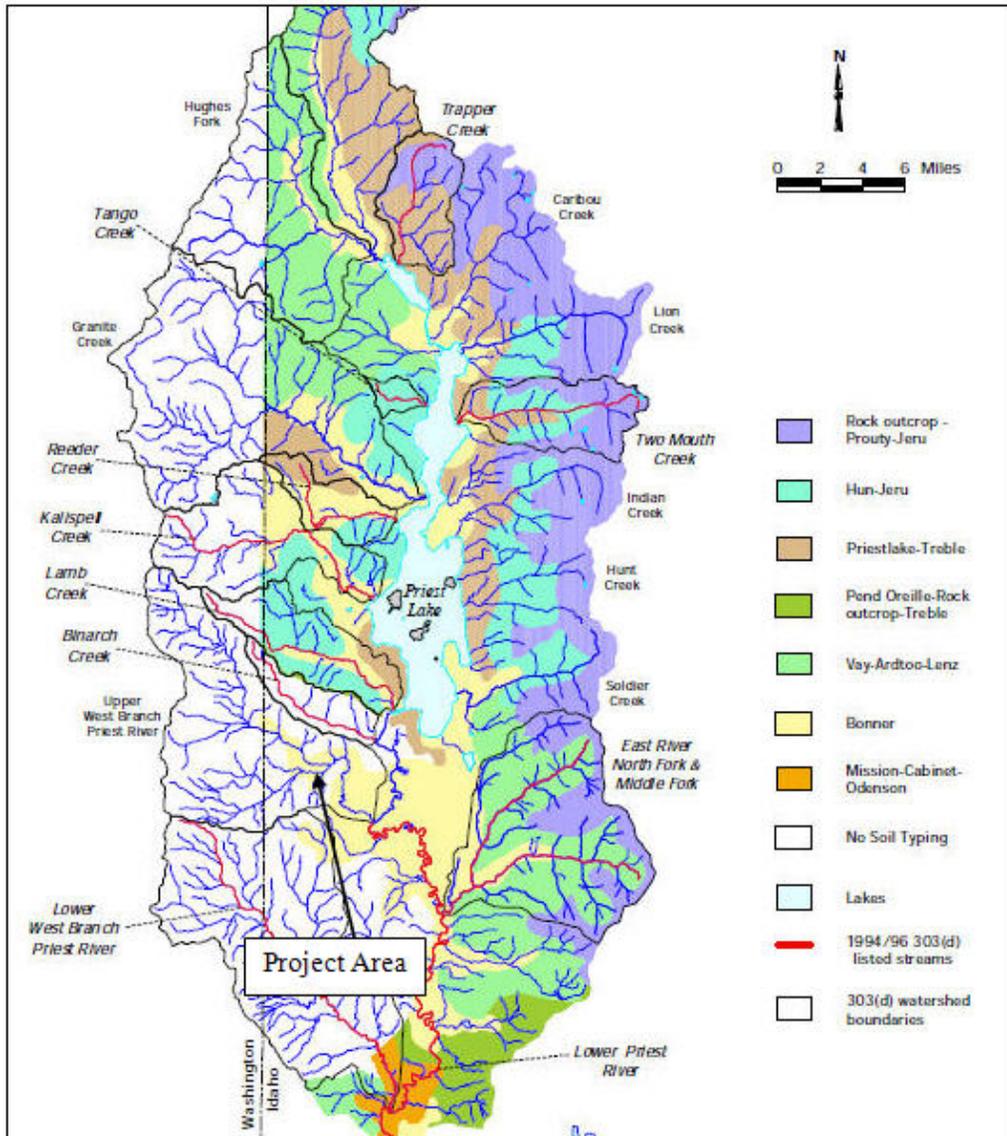
Figure 4. General soil types of the Priest River Basin (IDEQ, 2001).

The observed series of sands and overlying silts is consistent with soils mapping in the area. The soil unit mapped in the project reach is the Bonner General Soil Map Unit (IDEQ, 2001). The Bonner unit is of glacial outwash origin, with very deep, level to undulating, well drained soils. Its surface layer is silt loam, subsoil is gravelly silt or sandy loam, and the substratum is very gravelly loamy sand or very gravelly coarse sand.

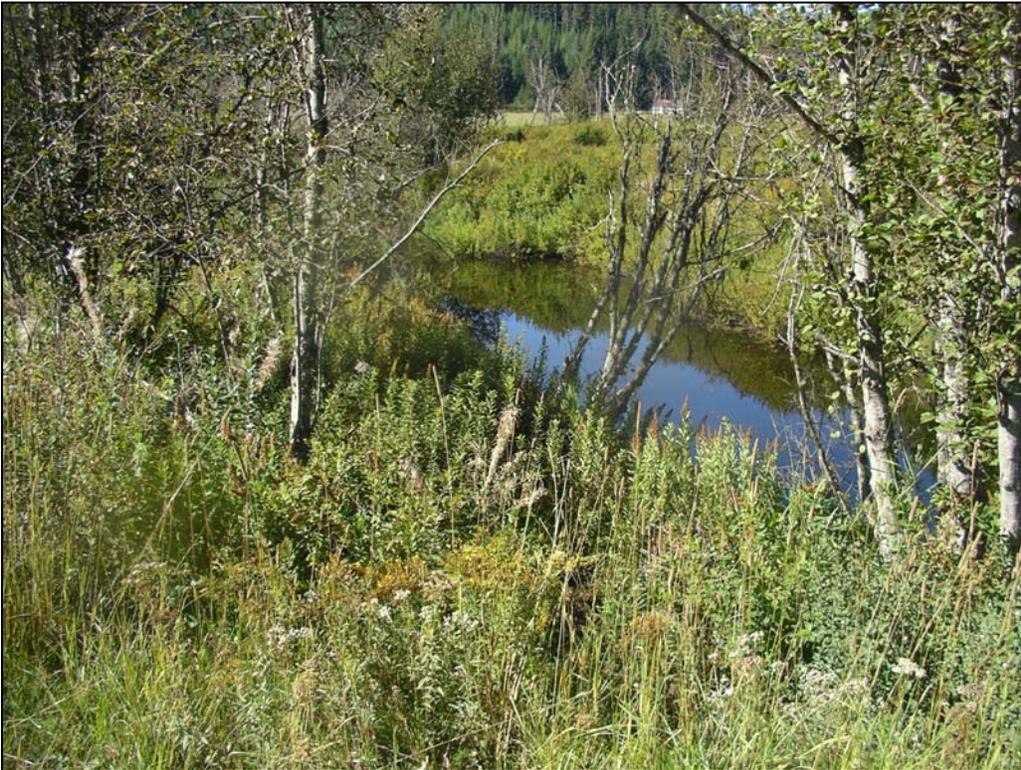
Figure 6. Goose Creek upstream of the upper Forest Service road crossing.

As Goose Creek exits the steeper, forested areas of the watershed and enters the flatter meadows, the creek has a high density of beaver complexes and good fish habitat complexity. At the upper Forest Service road crossing (not shown in Figure 5), the channel does not appear incised and has adequate access to a natural floodplain. Stream banks are well vegetated with mature alder providing an overstory layer and mixed grasses and forbs along the stream banks (Figure 6). The channel begins to show signs of incision downstream of the upper road crossing. Once the creek reaches the upper extent of the southwestern Tribal parcel, the channel indicates signs of incision and lateral erosion (Figure 7). Bank heights are much higher and an inset floodplain has formed at a lower elevation than the meadow. Many banks are not as densely vegetated and some near vertical as the channel has dropped in elevation. Vegetation density remains moderately dense and overstory canopy layers provide good shade and cover. Beaver dams remain relatively common and fish habitat complexity is good in Goose Creek upstream of the Tribal parcel.

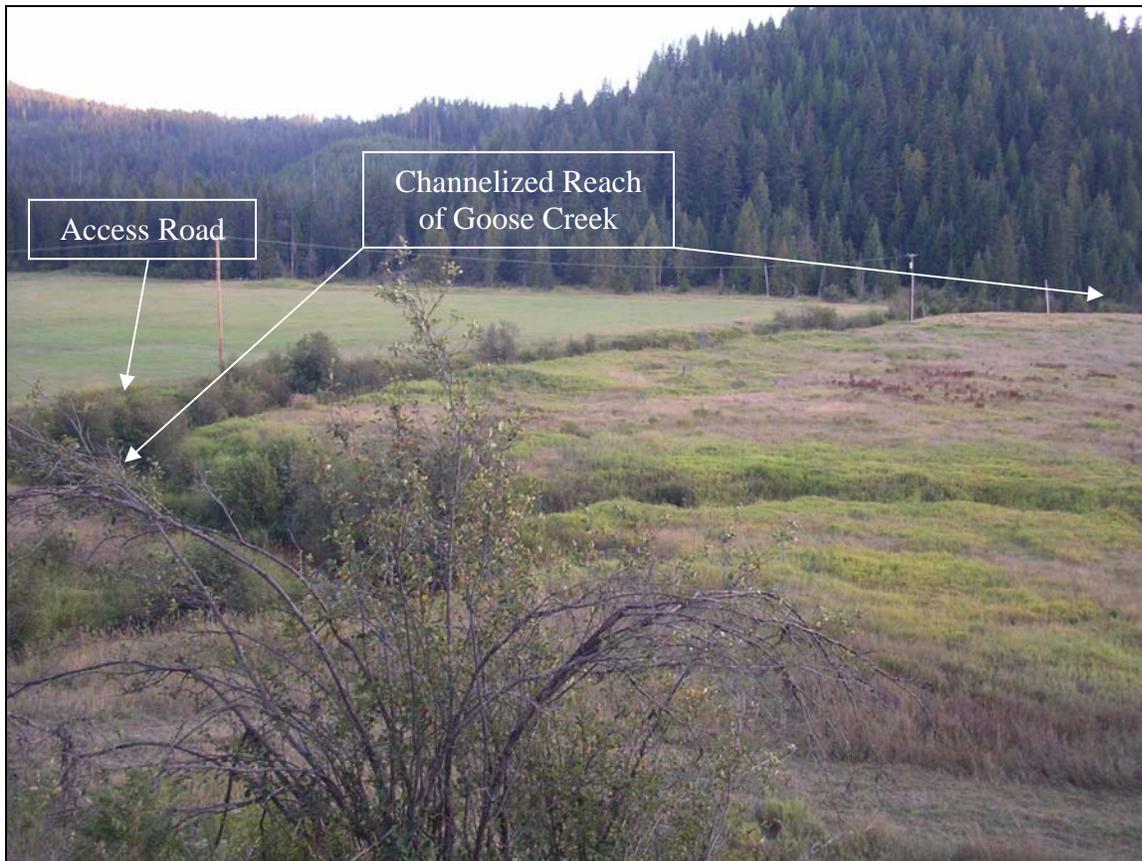
Figure 8. Channelized segment of Goose Creek in Reach A.

As the creek approaches the access road, it deviates from its historic meander pattern and enters a channelized reach which continues downstream to the bridge crossing. Once the creek becomes channelized, habitat complexity becomes drastically reduced. Pool quality is degraded due to the absence of meander sequences and shrub cover is reduced to a thin boundary of alders along the fringe of the channel. Much of the creek has been armored along the access road to protect it from eroding at high flows. Overall habitat quality in this channelized reach is poor due to planform simplification and altered riparian complexity.

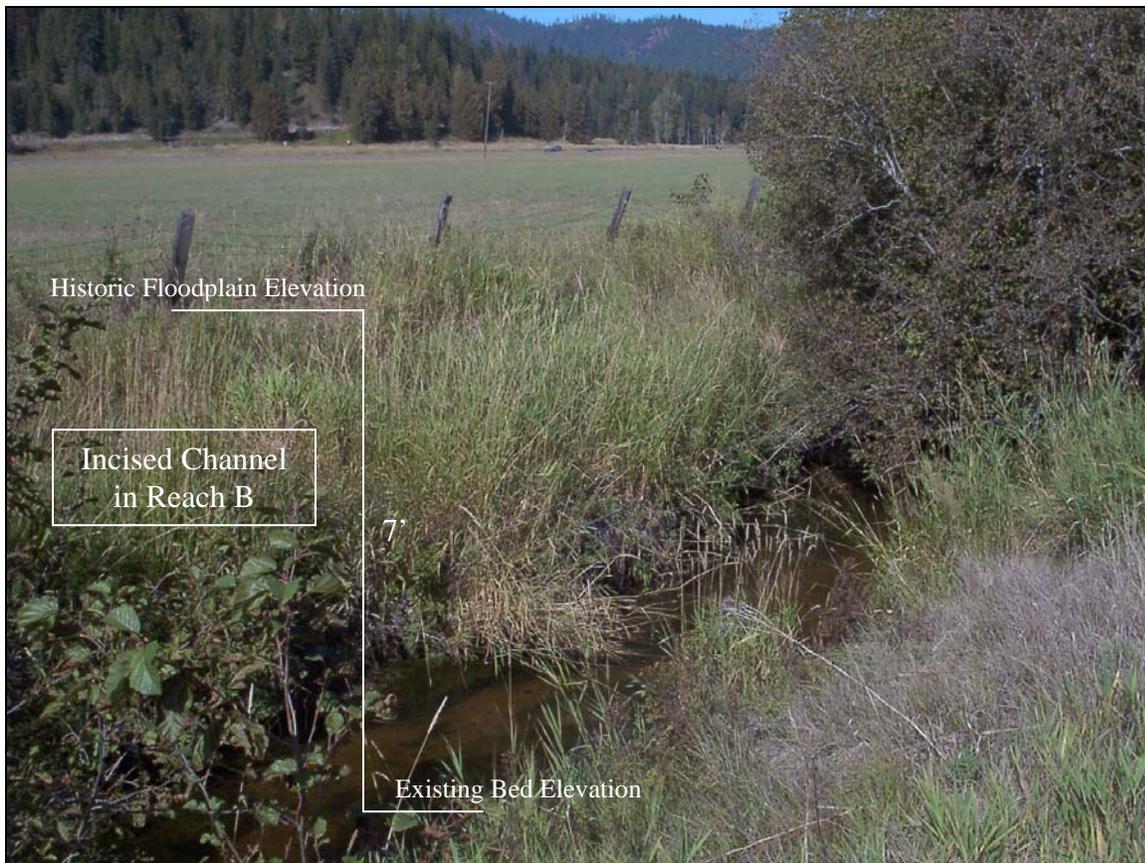
Figure 9. Channelized portion of Goose Creek in Reach B.

Reach B extends from the bridge crossing to a forested portion of the valley bottom. The entire length of Goose Creek in Reach B is channelized. The creek acts more like a drain and conveyance ditch through Reach B and has virtually no habitat complexity in the form of riffle/pool sequences. Aquatic habitat is available in the form of woody debris, as the channel is lined with large alders on both banks. The channel is moderately incised and drains adjacent hay pastures. Upland grasses and forbs grow down to the edge of the channel but provide little cover or habitat. Although the creek has been altered to maximize hay production in this portion of the valley, the stream banks have generally maintained lateral stability and riparian vegetation is vigorous along a thin band immediately adjacent to the creek. Overall habitat quality is relatively poor in Reach B due to simplified plan form, lack of a functional floodplain, and reduced riparian vegetation complexity.

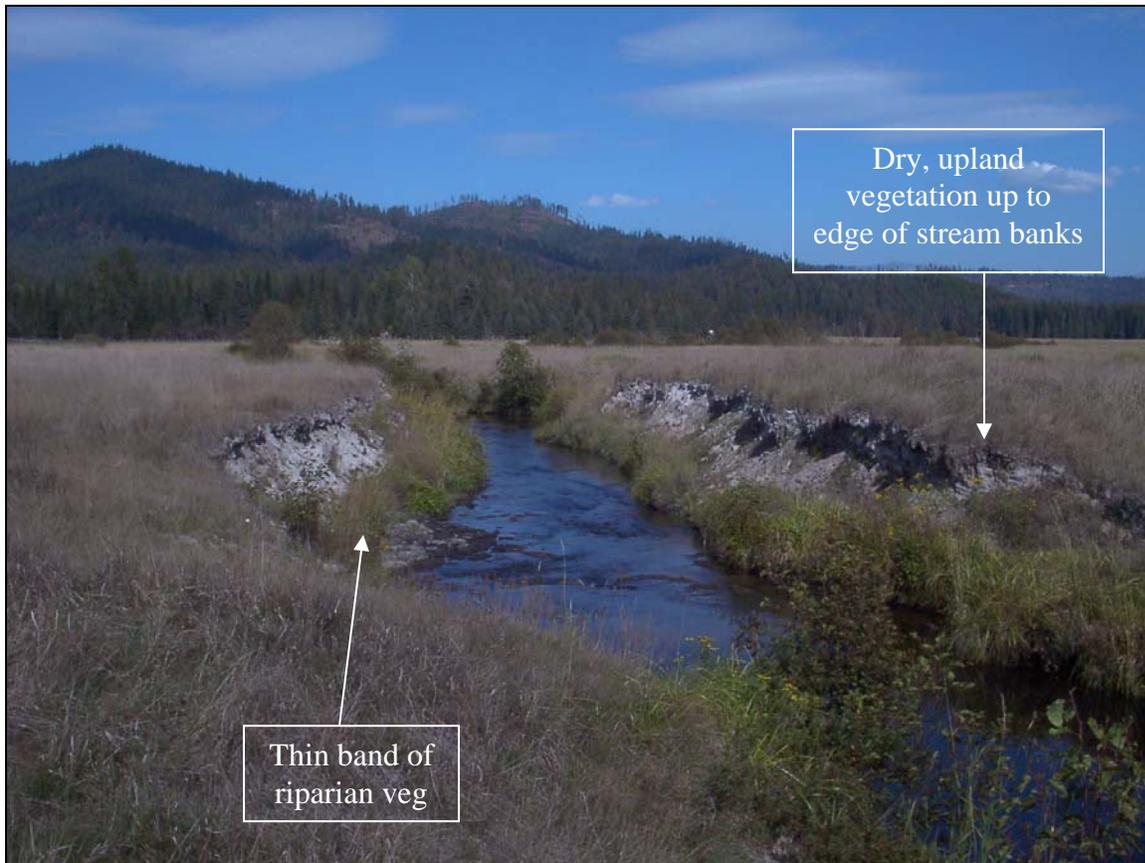
Figure 10. Goose Creek in the lower portion of Reach C.

Reach C of Goose Creek flows through a short, forested portion of the valley and continues into the center of Big Meadows. The channel returns to its historic meander pattern through this reach as identified by 1932 aerial photos. Although the channel displays a relatively natural sinuosity in Reach C, it also shows evidence of vertical incision of the stream bed, including an elevated meander cutoff, high banks, and thin band of riparian vegetation along the immediate banks. Habitat complexity improves in Reach C as compared to the channelized portions in Reaches A and B as the channel is able to scour pools on outside meander bends. Although habitat complexity begins to improve, the bed elevation of the creek is very low as compared to the meadow, and therefore acts as a drain for adjacent pastures used for grazing and producing hay. Riparian vegetation is relatively sparse due to a channel which has been disconnected from its historic floodplain. Bank erosion is evident by sloughing along much of the channel, which provides additional sediment inputs to the watershed.

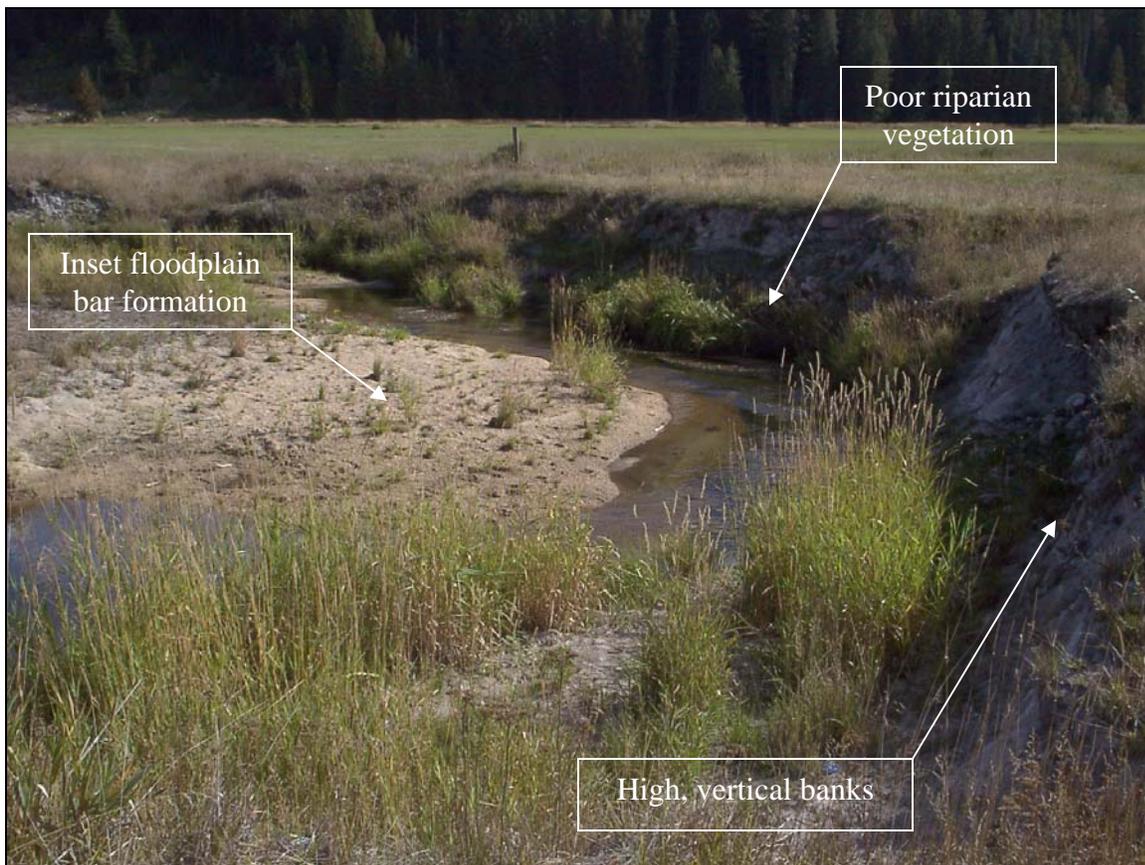
Figure 11. Goose Creek in Reach D showing inset floodplain formation and incised channel.

Reach D extends to a culvert which has been placed in the channel to provide a crossing for equipment access. The creek flows along nearly the same meander pattern as shown in 1932 aerial photography, indicating relatively minor lateral movements in the past 70 years. The channel continues to show signs of incision, including high bank heights, inset floodplain formation, and sparse riparian vegetation along the fringes of the channel (Figure 11). The relatively natural sinuosity in Reach D enables pool formation along the outside of meander bends that provide added habitat complexity. However, riparian vegetation throughout the reach has been reduced to a very thin band of grasses and occasional alders which provide little cover and shade. Overall aquatic habitat in Reach D is poor due to eroding banks, poor riparian vegetation density, and reduced floodplain connectivity.

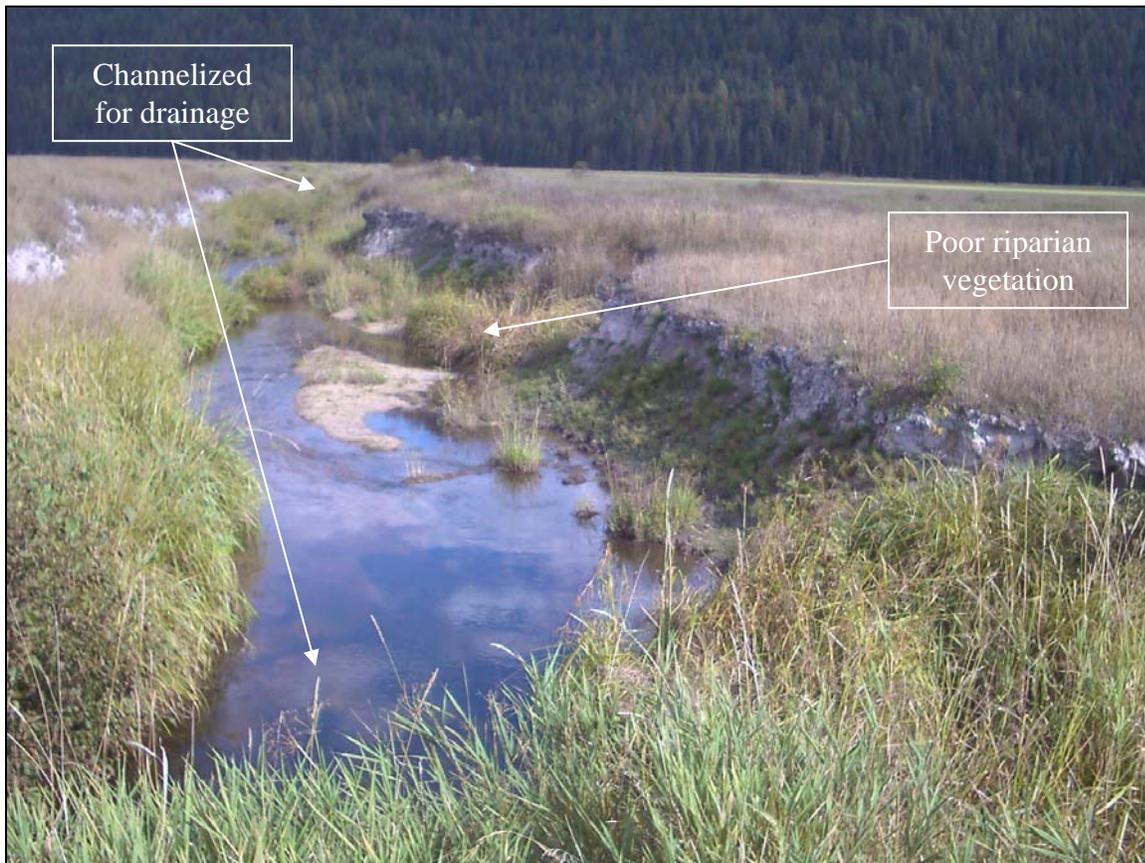
Figure 12. Channelized portion of Reach E.

Reach E of Goose Creek extends downstream of the culvert to a bridge crossing at the lower end of Big Meadows. The majority of this reach has been recently channelized and dredged (~10-15 yrs ago) to drain the meadow and improve hay production. As a result, habitat complexity is severely degraded and woody riparian vegetation is nearly absent throughout the reach. Sparse alders remain along the fringe of the channel and provide some cover and shade, but the majority of the channel has little overstory or canopy layer. Immediately downstream of the culvert, the channel remains incised with very high bank heights, one large meander cutoff, and upland vegetation growing up to the channel edge. The degree of incision lessens as the channel approaches the east side of the meadow, although it remains channelized to the bridge. As the channel begins to regain connectivity to its natural floodplain near the downstream end of the reach, vegetation characteristics favor more wetland species, denser alders, and spirea. Habitat complexity in Reach E is poor due to the simplified planform and highly altered riparian corridor.

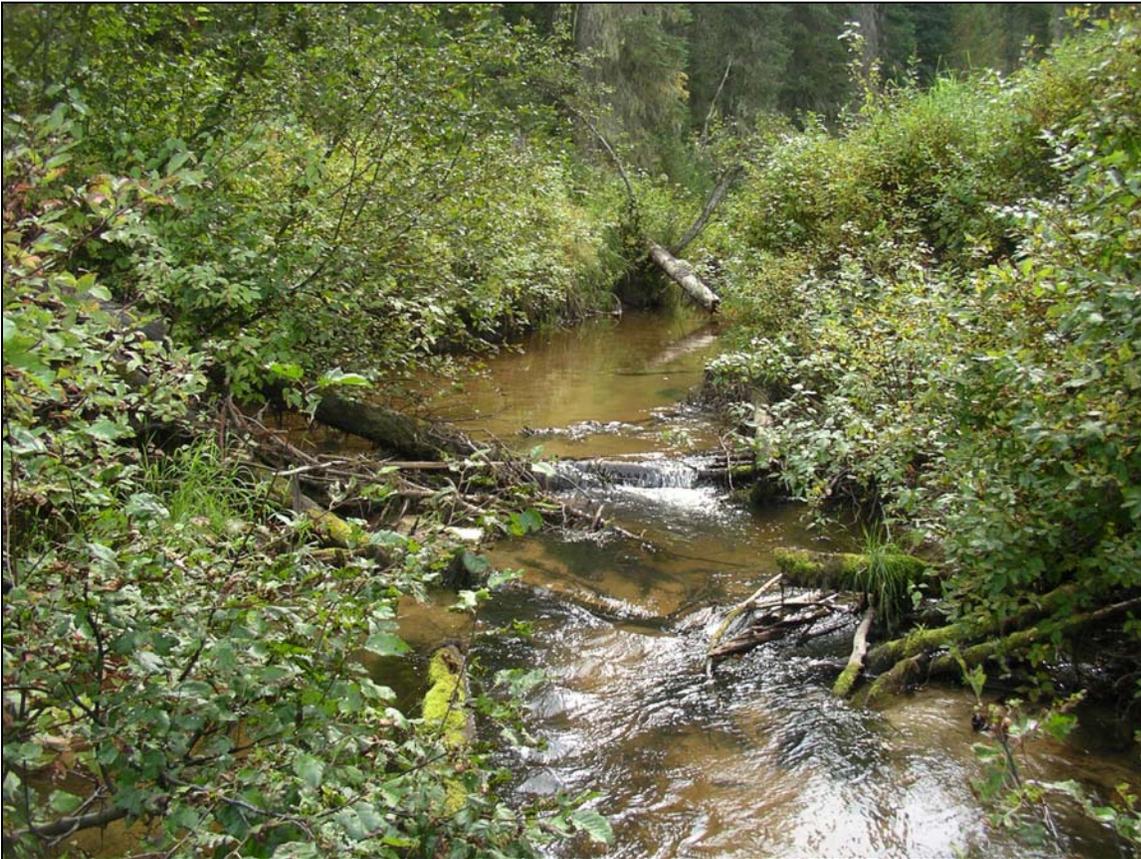
Figure 13. Goose Creek in Reach F just upstream from the confluence of the Upper West Branch of the Priest River.

Reach F of Goose Creek extends downstream of the bridge at the east end of the meadow to the confluence of Goose Creek and the Upper West Branch of the Priest River. Although short, this reach exhibits some of the most superior habitat conditions in the lower watershed. The channel has not been mechanically altered downstream of the bridge and channel incision is not evident. Riparian vegetation is dense and provides ample cover and protection from bank erosion. The channel abuts a forested hillside which provides a source of woody debris and habitat complexity. Surveys in Reach F provide potential reference conditions for habitat, channel dimensions, and riparian vegetation composition for other reaches upstream of Reach F.

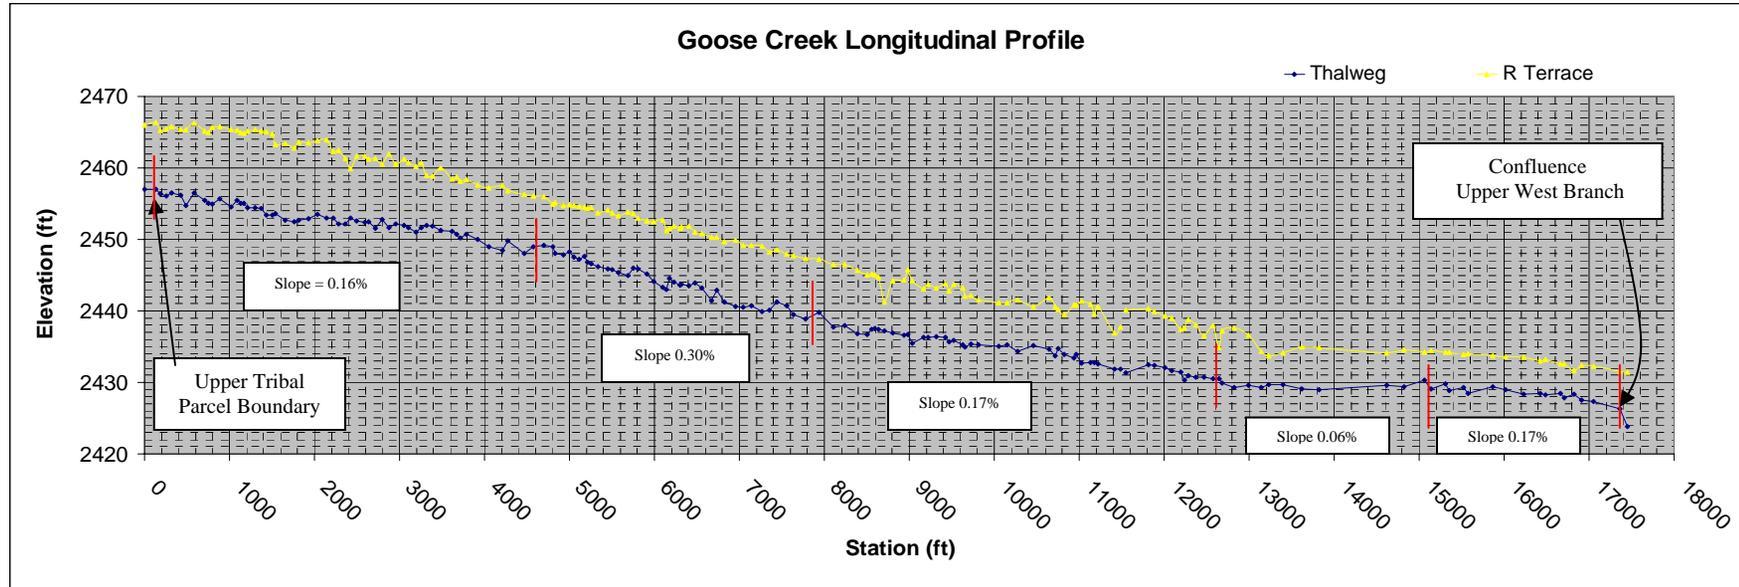
Figure 14. Longitudinal profile of Goose Creek showing thalweg and terrace elevations.

Tribal fisheries technicians completed a longitudinal profile of Goose Creek, including elevations of terraces, bankfull indicators, and the channel thalweg. Results of this survey allow calculations of channel slope throughout the project reach starting from the upper Tribal parcel boundary to the confluence of Goose Creek with the Upper West Branch (Figure 14). The red lines on this figure delineate breaks in channel gradient and do not correspond to the reach breaks illustrated in Figure 5.

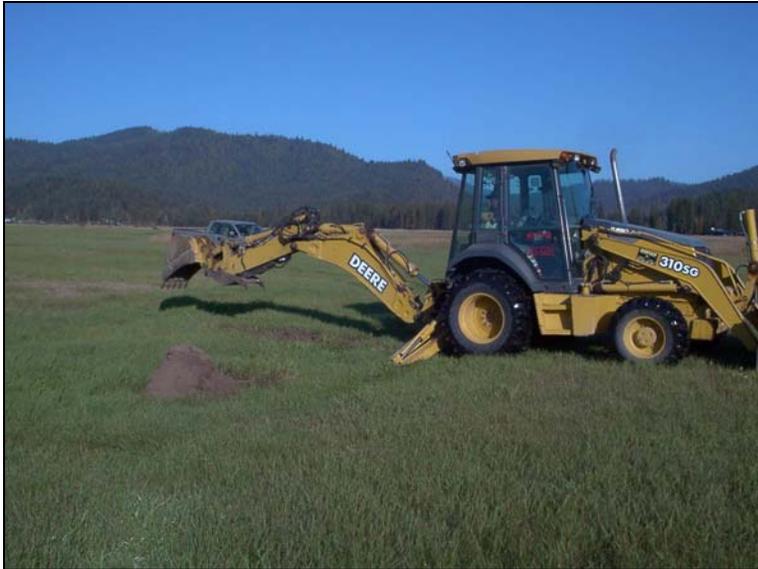
Figure 16. Backhoe used in soil pit excavation (Soil Pit 1).

In the fall of 2009, six soil pits were excavated by backhoe within the project reach to characterize subsurface materials (Figure 16). Pit locations were selected to provide a general representation of subsurface conditions on the anticipated reconstructed channel course (Figure 17). Total pit depths ranged from 6.5 to 9.5 feet; maximum excavation depths were limited by pit wall stability, groundwater levels, or backhoe reach (Figure 18). Appendix C contains the field logs collected for each pit.

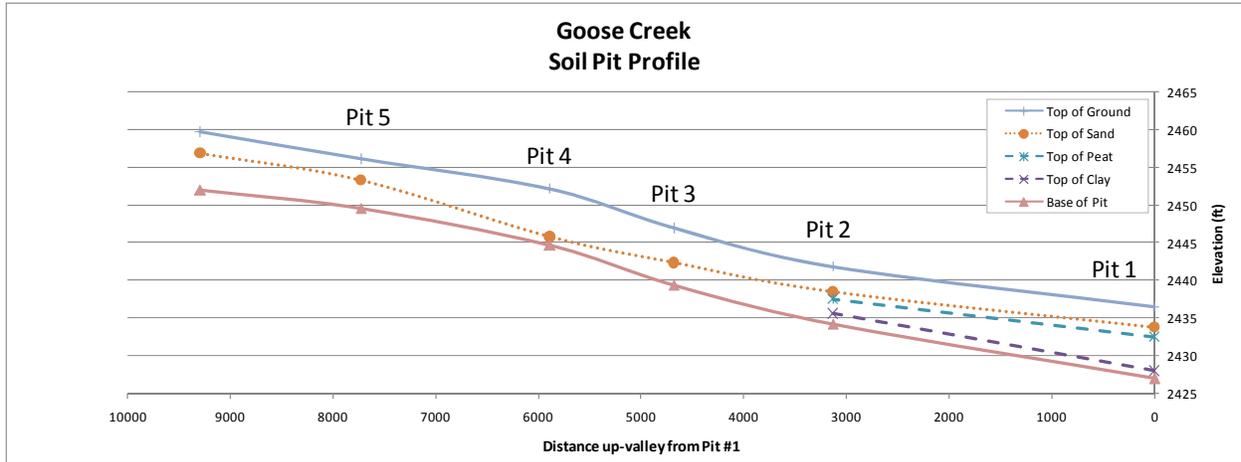
Figure 19. Soil pit profile compiled from pit logs and site elevation survey.

A generalized profile of the observed pit stratigraphy is shown in Figure 19. The plotted results show that in the lower portion of the valley, clay and peat were encountered in the deepest portion of the section. The clay encountered at the base of both Soil Pit 1 and Soil Pit 2 consists of a blue/gray, highly cohesive massive clay (Figure 20). The unit was 1.0 to 1.3 feet thick, which should be considered a minimum thickness as the lower contact elevation is unknown. In Soil Pit 2, the clay contained some interbeds of gray sand.

Overlying this unit, a peat unit ranges in thickness from 4.5 feet in Soil Pit 1 to 2.0 feet in Soil Pit 2, indicating that the unit may thin in the up-valley direction. This unit consists of a brown peat that has a low density and contains distinct reedy plant fragments (Figure 21). Neither the basal clay nor overlying peat were observed in any of the pits located up-valley from Pit #2. If these units were deposited in relatively flat lake or bog conditions, they likely extend up-valley at a deeper level than that reached by Pits #3 through #6.

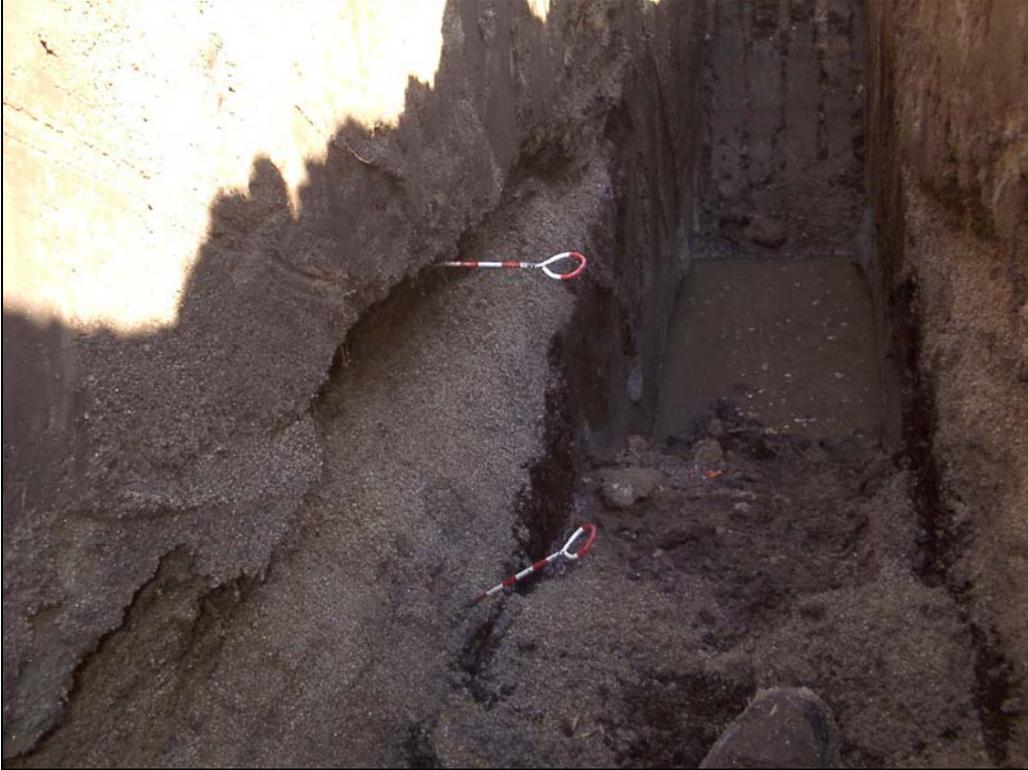
Figure 22. Wall of Soil Pit 2 showing non-cohesive, sand channel overlying peat.

In Soil Pit 1 and Soil Pit 2, the peat layer was overlain by non-cohesive, granitic sands that contain distinct channels, reflecting deposition in a fluvial or deltaic environment (Figure 22). This sand horizon extends upvalley, forming the basal section of Soil Pits 3, 4, 5, and 6. The concentration of wood fragments in this sand horizon increased markedly in the up-valley direction (Figure 23).

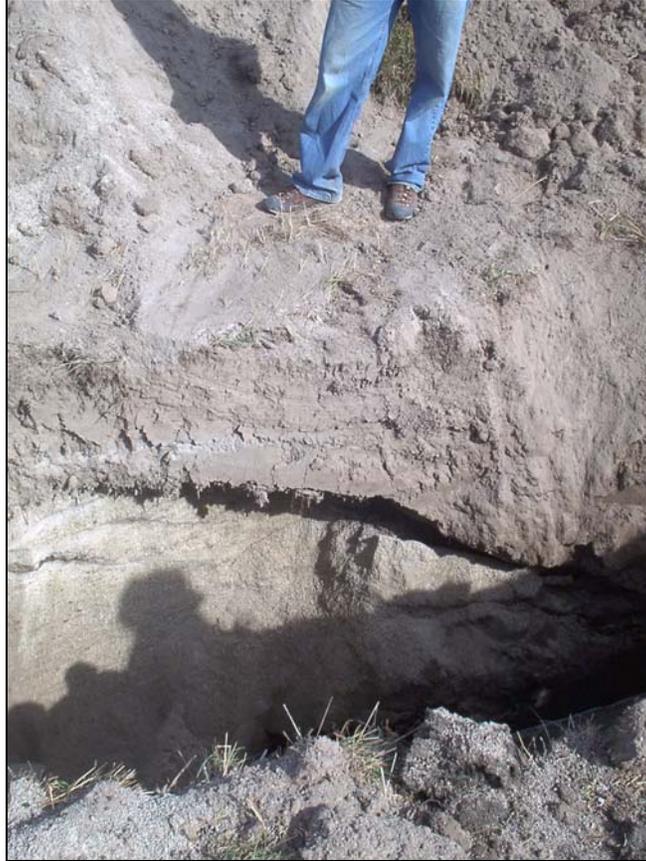
Figure 24. Massive silts overlying a convex point bar deposit of non-cohesive sands, Soil Pit 5.

In all of the soil pits, the sand horizon was overlain by variably stratified fine silts. In some locations, a distinct ash horizon was present within the silt. This unit was consistently several feet thick and sufficiently indurated to provide stability to the pit walls. In most cases, the uppermost portion of this unit was massive and structureless, suggesting that it had been tilled as part of agricultural activities in the valley. In Pit 5, the silts overly a non-cohesive, convex bar deposit that suggests overbank infilling of an abandoned channel segment (Figure 24).

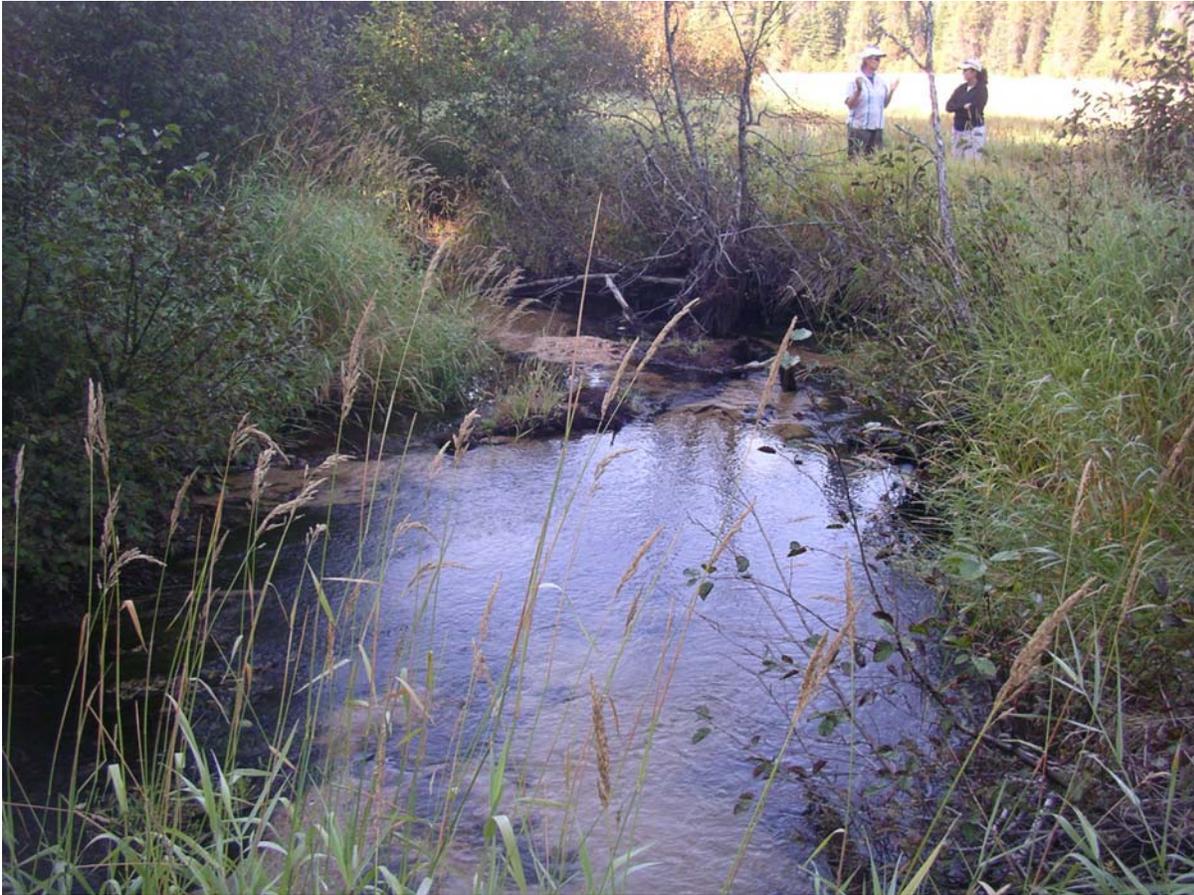
Figure 25. Photo of Upper West Branch of the Priest River in reference reach.

In addition to the surveys performed along Goose Creek, a potential reference reach was identified on the Upper West Branch (UWB) of the Priest River. This reach of the Upper West Branch also flows through a meadow complex and visually exhibited similar sand-dominated substrate and channel dimension as Goose Creek. The selected reach showed no influence of anthropogenic alterations upstream or downstream and displayed a healthy riparian corridor and intact floodplain. Reference reach surveys included:

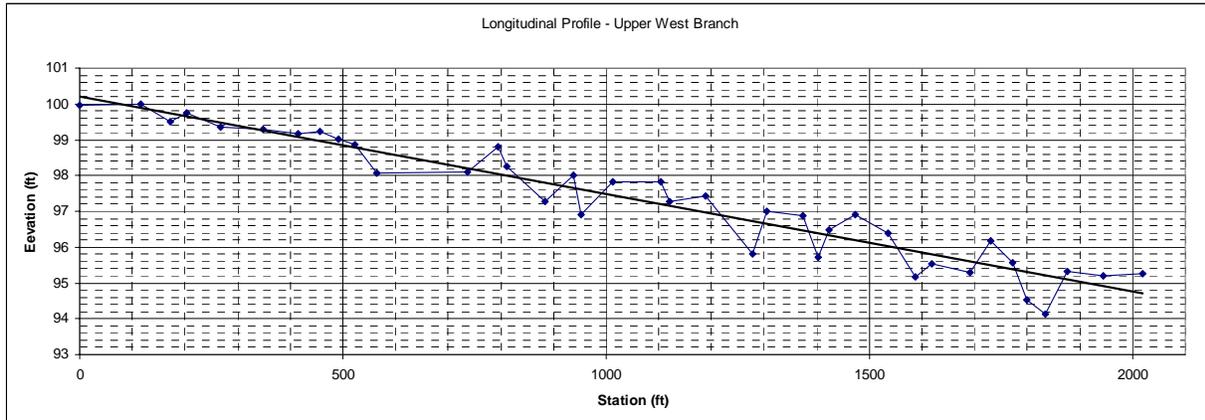
Figure 26. Longitudinal profile of Upper West Branch reference reach.

A 2,000 foot longitudinal profile was surveyed in the selected reference reach of the Upper West Branch. Results of this profile allow for comparisons of channel slopes to those found in Goose Creek. Results of the longitudinal profile are illustrated in Figure 26. Thalweg slope averaged 0.0025 ft/ft for this reach of the Upper West Branch.

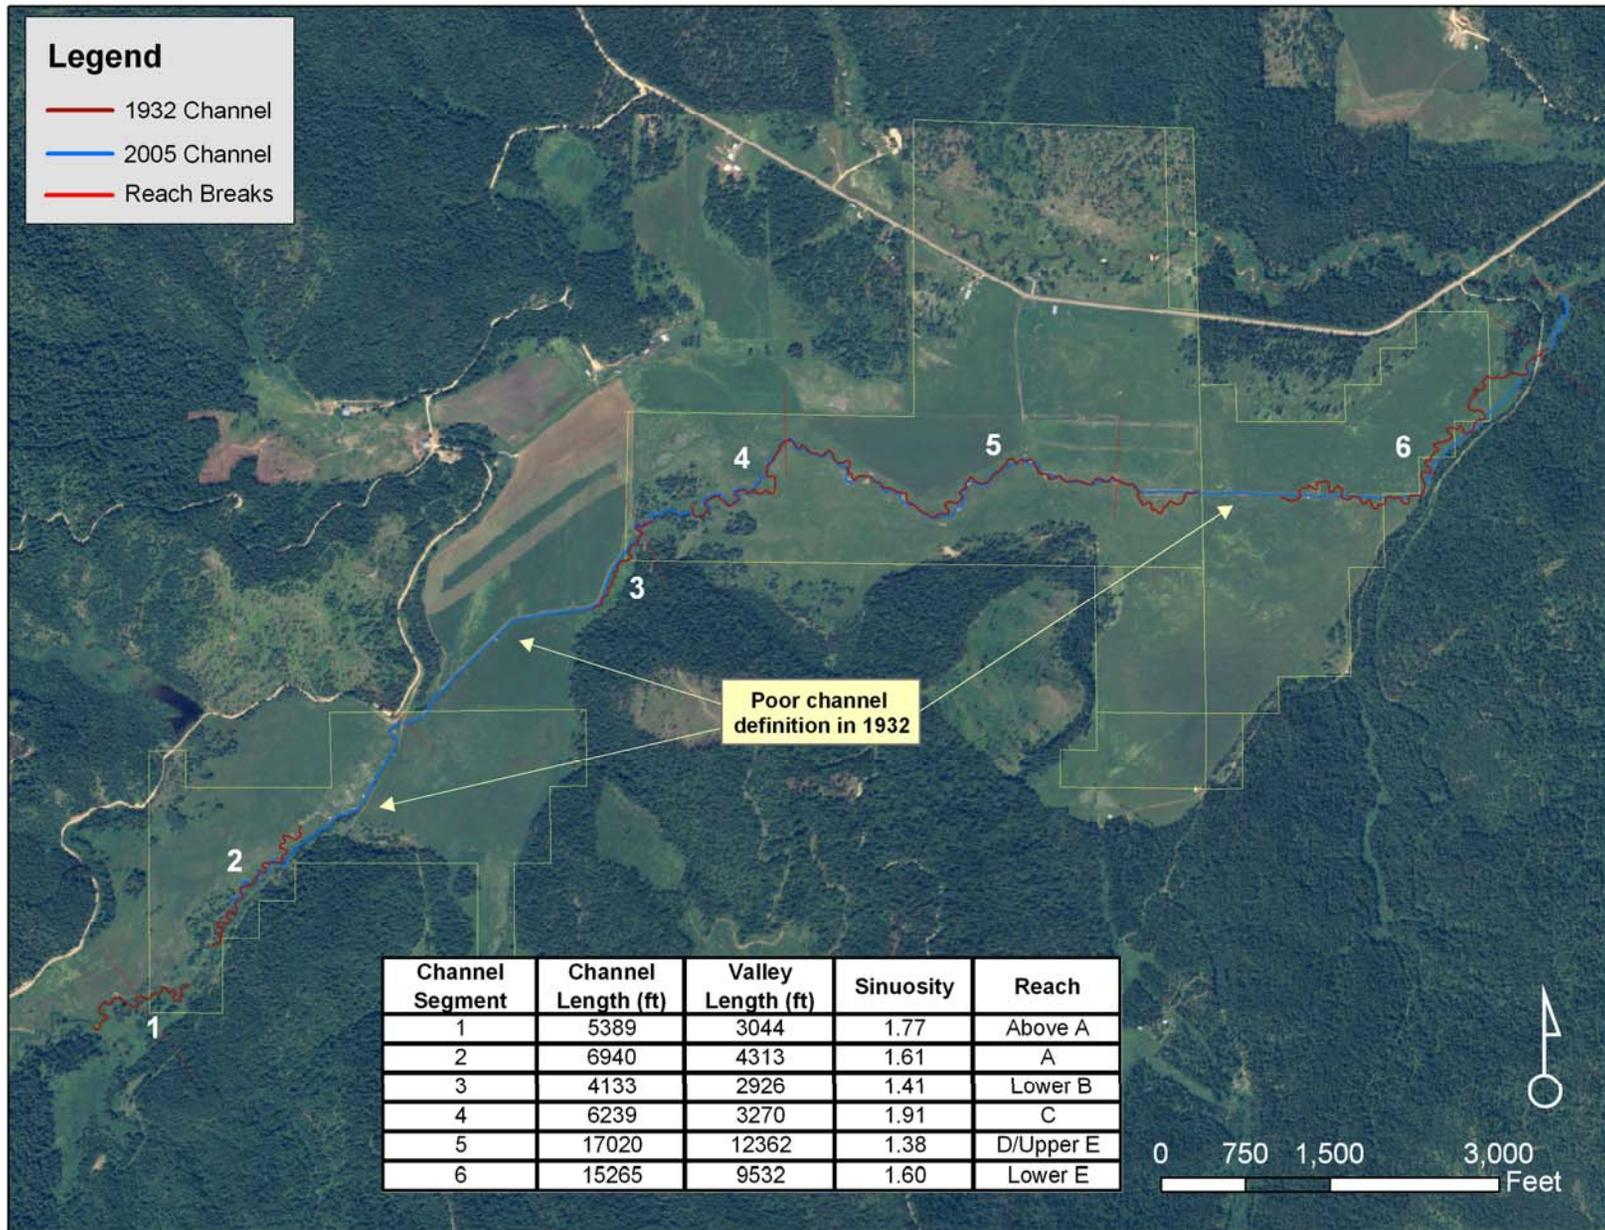
Figure 27. Historic and existing channel planforms and calculated sinuosity of Goose Creek in Big Meadows.

Historic segments of Goose Creek were digitized to determine channel sinuosity at various locations within Big Meadows and to provide design guidance for the restored stream. The 1932 photography revealed reaches within Big Meadows where the channel lost definition, resulting in discontinuous channel digitization. Poor channel definition may be due to areas of the meadow that are particularly flat and contain a braided channel, areas where the channel has a very dense riparian corridor which overlays the channel, or where the reduction in image quality prevents obvious identification of the channel. Figure 27 illustrates historic and existing channel planform of Goose Creek through Big Meadows and includes calculated sinuosity for each digitized channel segment. Channel segments in this figure do not necessarily correspond to slope breaks in Figure 14 or reach breaks in Figure 5.

Each of these planform components was measured for each meander sequence within each of the 1932 channel segments illustrated in Figure 27. An example illustration of digitized meander lengths, belt widths, and radius of curvature from the 1932 aerial photos along lower Reach E is shown in Figure 28. Meander geometry results for each channel segment are included in Table 13.

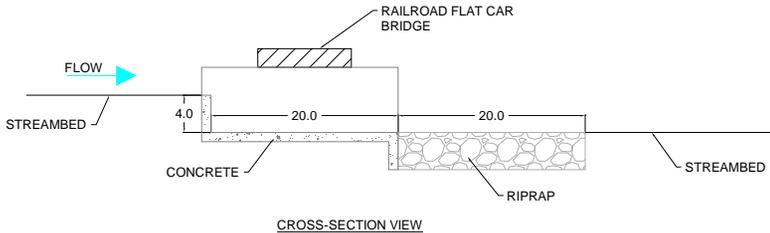
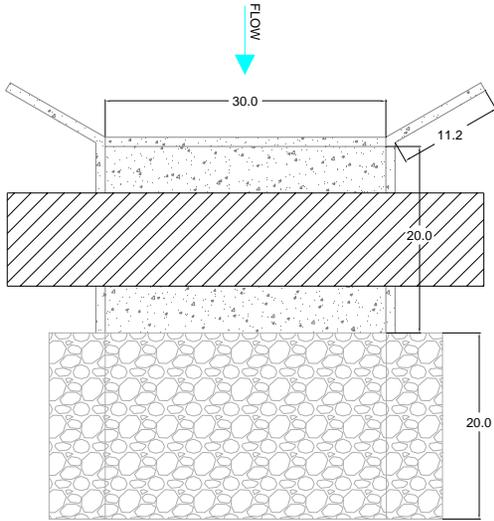
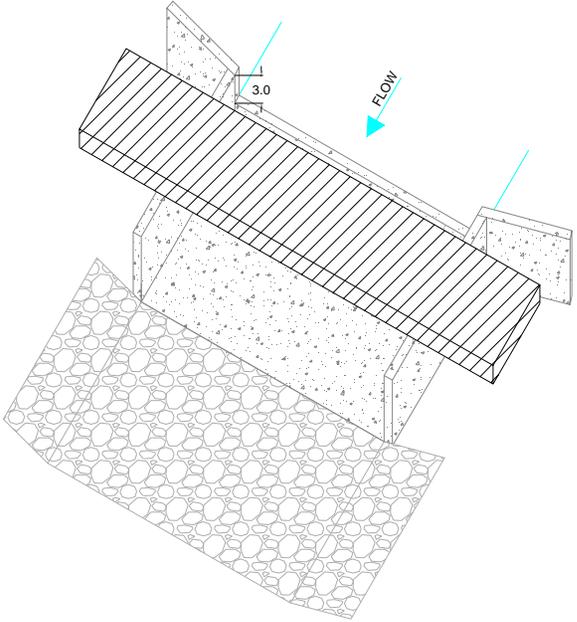
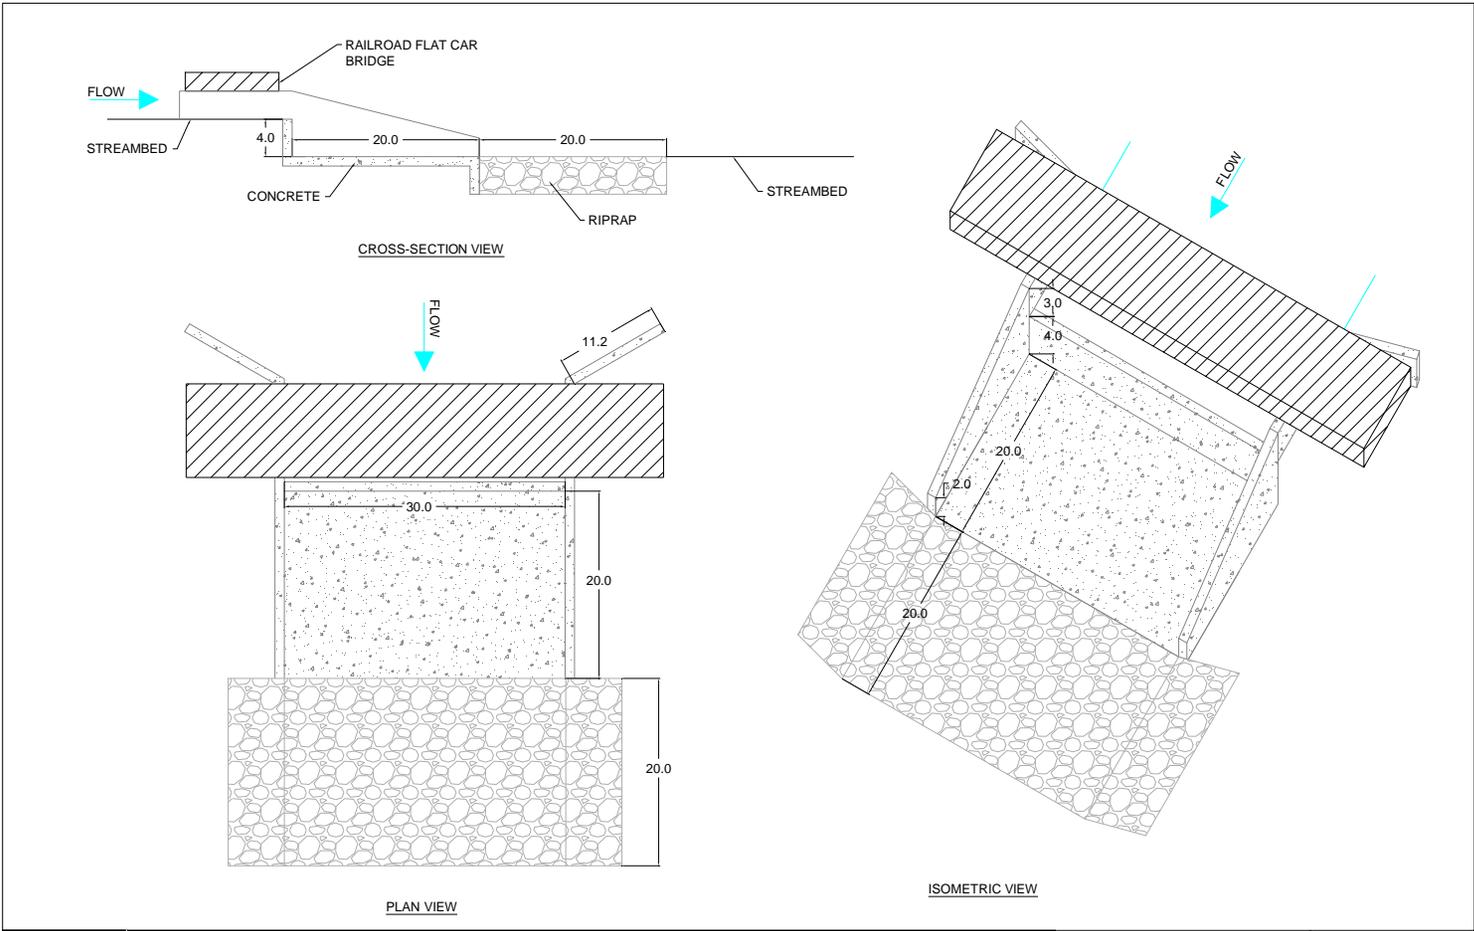
Goose Creek Conceptual Fish Barrier Design Road and Bridge on Top of Berm

PLAN VIEW

ISOMETRIC VIEW

A floodplain dike will be constructed to maintain the fish passage barrier at high flows. The foundation and core of the dike should be constructed with suitable materials such as clay or gravel to prevent breaching at high flows. The clay layer could be capped with topsoil for revegetation purposes. A geotechnical analysis of existing soil conditions, permeability, and potential borrow sources is highly recommended during final engineering designs.

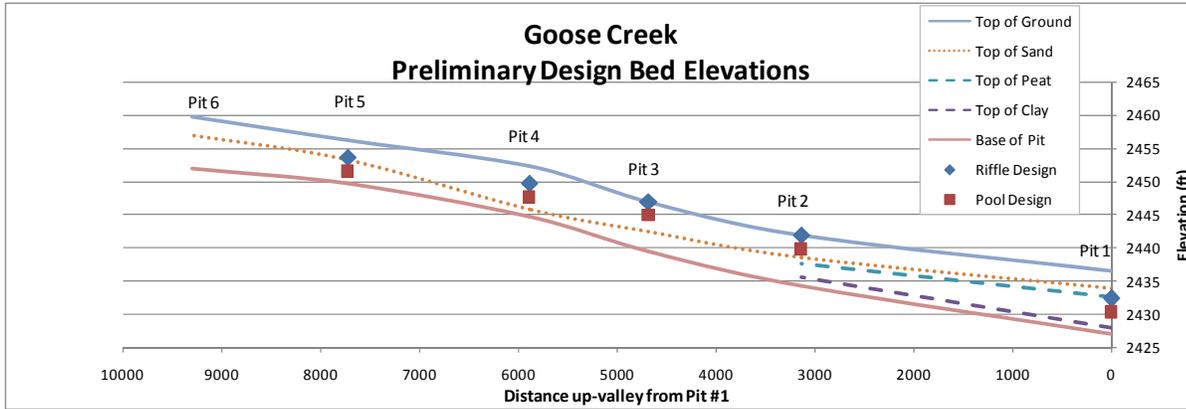
Figure 29. Valley fill stratigraphy and proposed riffle/bed elevations.

At the locations of Soil Pits 4, 3, and 2, the proposed channel is anticipated to be fully bound by cohesive silts, which will provide significant bank stability that will allow for complex planform elements, and maintenance of relatively low width to depth ratios once the banks are well vegetated. Planform stability will rely on wetland and woody species colonization along the banks. No significant wetland sod borrow sources were identified in the vicinity of the project reach; therefore it is recommended to refrain from activating these channel segments for 1-2 years following excavation. This timeframe will allow revegetation efforts to mature and wetland vegetation to establish along the channel fringe.

At Soil Pit 1, the channel will be held within a deeper, compound cross section that contains an inset floodplain margin. As a result, the deeper cross section will extend down through the sands and into peat for both riffles and pools. Peat is similarly exposed in the bed of the existing channel to the north (Figure 30). Although bank failure is common in that channelized segment, the role of peat in that instability is unclear. This layer will not provide immediate bank and bed stability, although it may provide a rich source of seeds and organic matter. This layer may provide a very suitable medium for revegetation of the floodplain and stream banks. As stated earlier, it would be advantageous to refrain from activating this channel segment immediately following channel construction, and wait 1-2 growing seasons for revegetation efforts to mature.
